White Mountain Covered Bridges

Honeymoon Bridge, Jackson NH

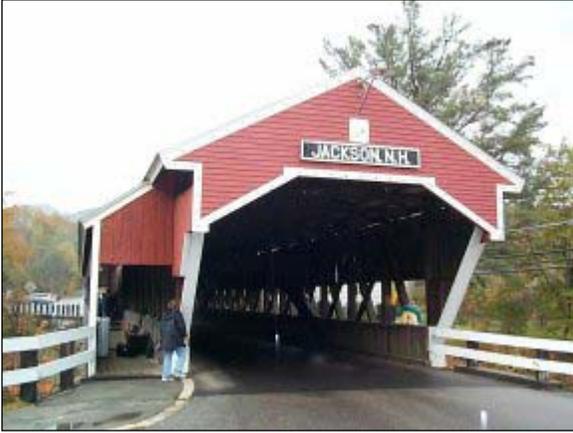
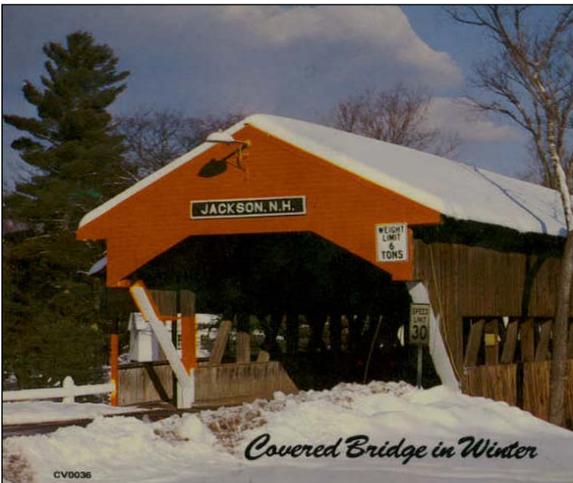
Paddleford truss

The bridge is 121' 1" long with a clear span of 103' 0". It has an overall width of 26' 5" with a roadway width of 16' 0", and

a maximum vertical clearance of 12' 3". It has a sidewalk on the upstream side. The structure was built with exposed sides. It is posted for six tons.

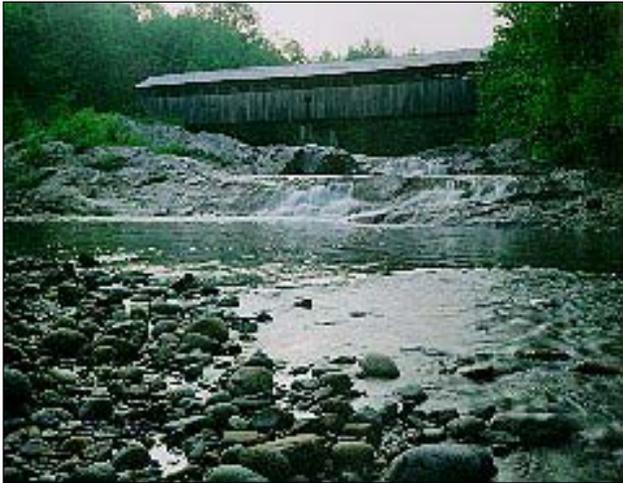
Swiftwater Bridge, Bath NH

Paddleford truss with added arches

The bridge is 158' 4" long with clear spans of 77' 6" and 57' 6". It has an overall width of 21' 0", a roadway width of 14' 6" and a maximum vertical clearance of 12' 9". The bridge is posted for six tons.

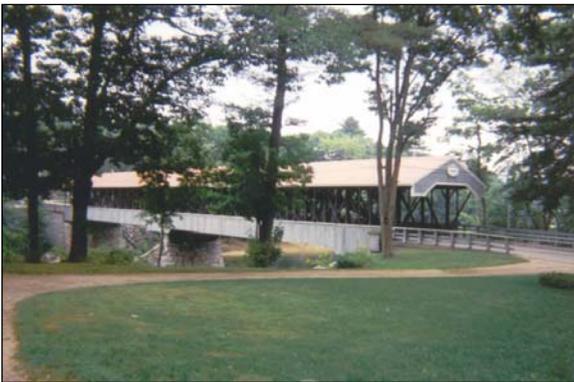
Saco River Bridge, Conway NH

Paddleford truss with added arches

The bridge is 224' 9" long with clear spans of 103' 4" and 95' 4". It has an overall width of 30' 4" with a roadway width of 18' 3" and a maximum vertical clearance of 13' 7". It is posted for six tons.

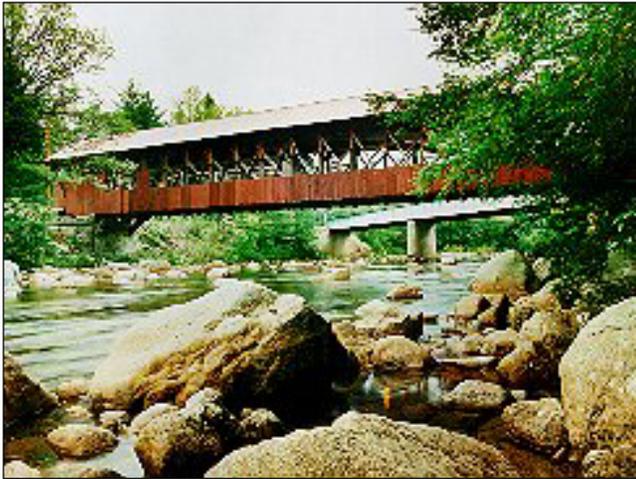
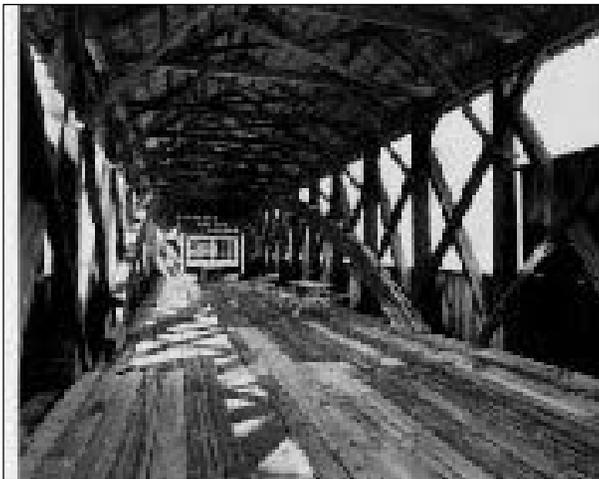
Bartlett Covered Bridge, Bartlett NH

Paddleford truss with added arches

The bridge is 166'10" long with a clear span of 145'0". It has an overall width of 20'4" with a roadway width of 16'6" and a maximum vertical clearance of 14'6". It is closed to vehicular traffic but pedestrians may walk across the structure.

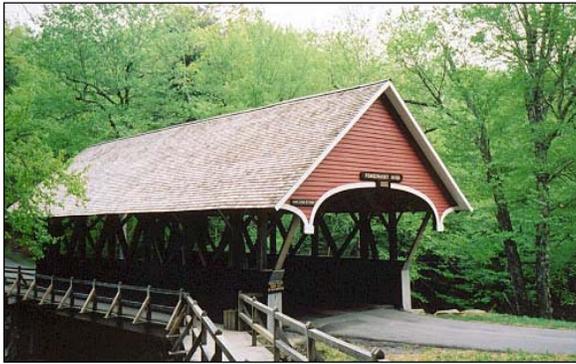
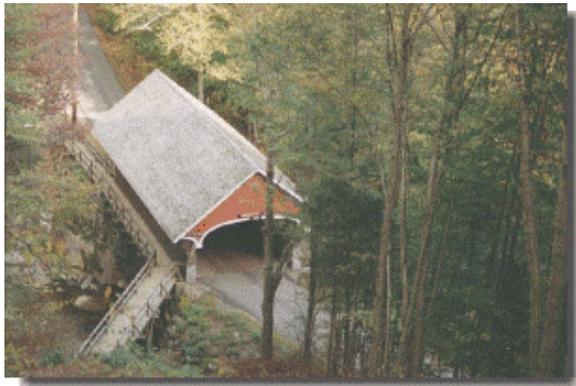
Flume Bridge, Lincoln NH

Paddleford truss

The bridge is 50' 0" in length with a clear span of 41' 4". It has an overall width of 20' 9", a roadway width of 17' 6", and a maximum vertical clearance of 11' 8". There is a hiker's walkway attached to the north side.

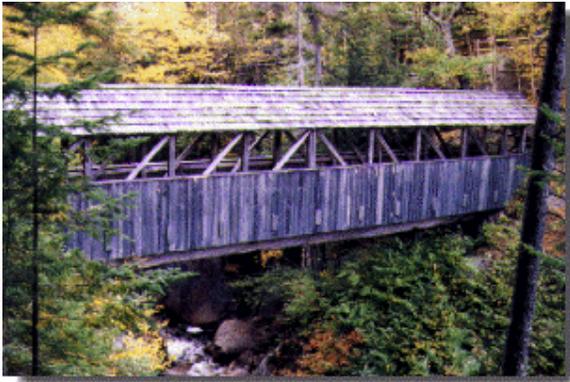
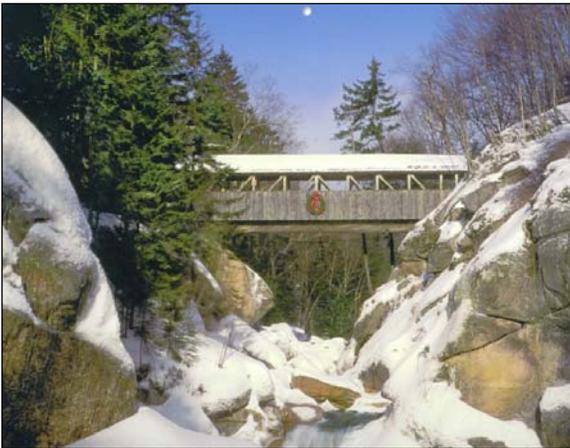
Sentinel Pine Bridge, Lincoln NH

Stringer

The bridge is 60' 5" long with a clear span of 50' 0". It has an overall width of 8' 2" with a roadway walking path width of 5' 5" and a maximum vertical clearance of 6' 2". The bridge is restricted to pedestrian traffic only.
